Guidance for Service Termination Issue Reporting

**A guide for MOCOPA Operators on reporting and acting on
Distribution Business asset condition issues**

Version: 3.7
Status: Final
Date: July 2021

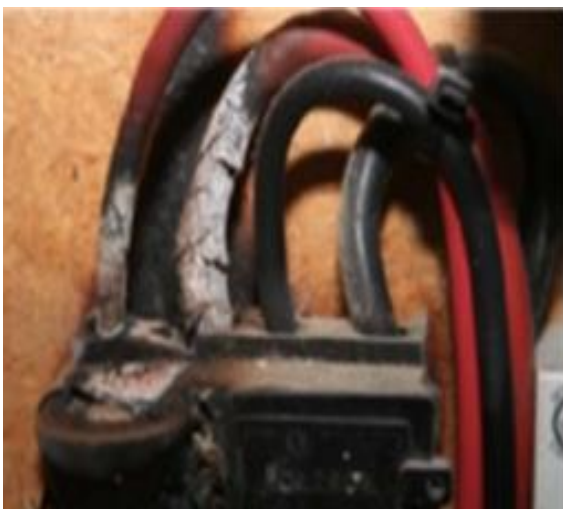
- Visual signs of the cut-out or service cable overheating;
- Equipment may smell and be giving off fumes;
- If it is an older type of cable (e.g. paper/lead) it may be discharging an oily substance
- Cut-out leaking bitumen/compound. If you see evidence of minor historic issues do not report A01 and instead report as Code C02;
- Signs of distortion in casing or darkened areas on the outside (modern cut-out).

Cut-out with visual signs of overheating

- Do not continue to operate the DB equipment until the issue has been resolved by the DB;
- Keep the immediate area clear of obstructions and keep everyone at a safe distance;
- If the cause appears load-related, advise the customer to reduce their load as appropriate;
- Contact the DB immediately by telephone – report as Code A01;
- Tell the DB what actions you have taken;
- Remain on site until the DB staff arrive;
- Ensure that you have provided all the details to the DB as specified in Section 5 Category A Issues;
- Continue to monitor the issue and inform DB if the situation deteriorates.

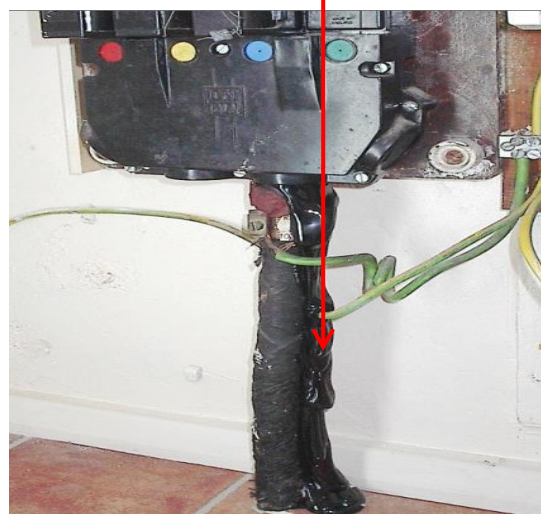
Cut-out with signs of bitumen leaking

Bitumen has been used for many years to fill voids and seal joints in electrical equipment. It has a relatively low melting point, so bitumen leakage may indicate overheating. The cause of any leakage may be historic, e.g. if previous load patterns or the ambient temperature at the service position are very different to present day arrangements. Alternatively, the cause may be related to an ongoing issue. Recent dust and dirt on the bitumen may help you to distinguish between ongoing and historic issues.

When load is high, bitumen may become hot enough to soften and start to leak, often dripping onto the wall or floor below. Bitumen may also be softened by oils from an oil impregnated cable, which combines with the bitumen and causes it to leak.

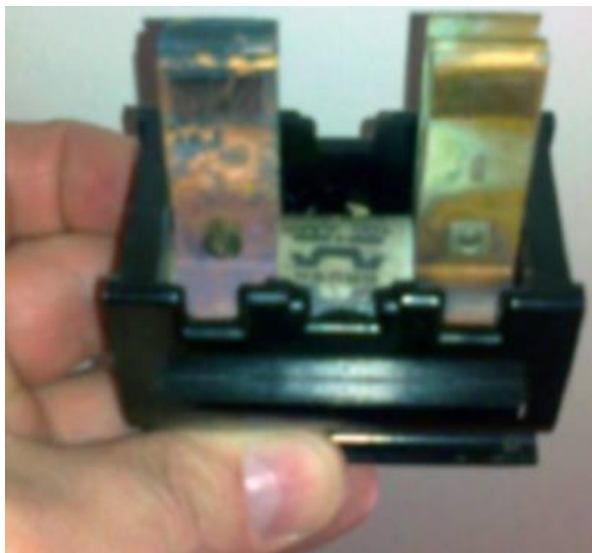
When you inspect and/or remove the fuse carrier and you see that the fuse carrier contacts are damaged or in such poor condition that arcing has previously occurred or is currently taking place under load conditions.

Weakened fuse carrier contacts

When fuse carriers become overheated they lose their "springiness".

- Remove the fuse from the fuse carrier;
- Replace the fuse carrier into the cut-out, to make the cut-out safe and remove exposure to live contacts;
- If there are no exposed parts, secure the empty fuse carrier using appropriate seals (as per MOCOPA Appendix 8).

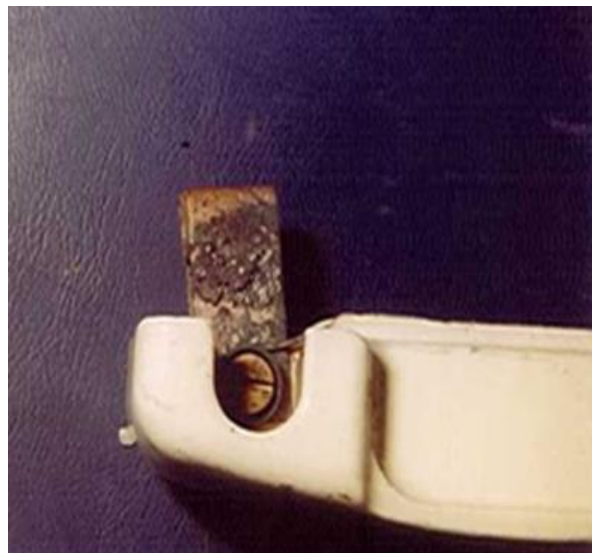
Pitted blade, due to making poor contact

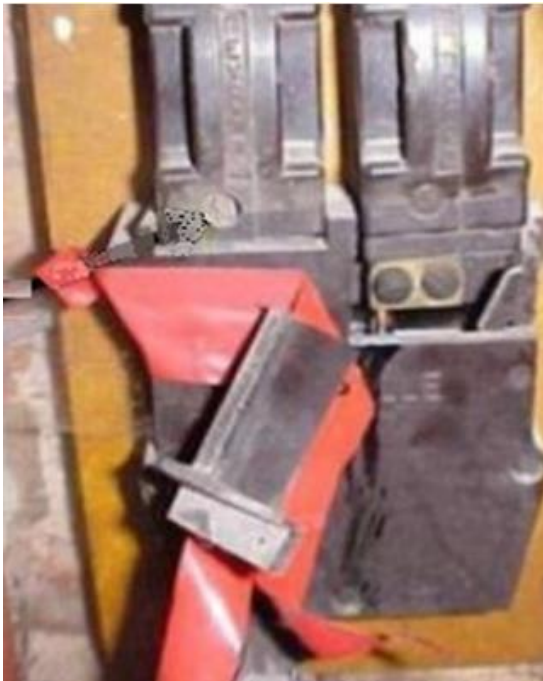
The DB equipment is damaged e.g. broken or severely cracked/damaged cut-out casing or service cable that requires immediate action (see detailed guidance below).

Severely damaged cut-out casing

- Do not continue to operate the DB equipment – unless mitigating actions have been taken to allow work to continue;
- If you are remaining on site for the DB to attend, keep the immediate area clear of obstructions and keep everyone at a safe distance;

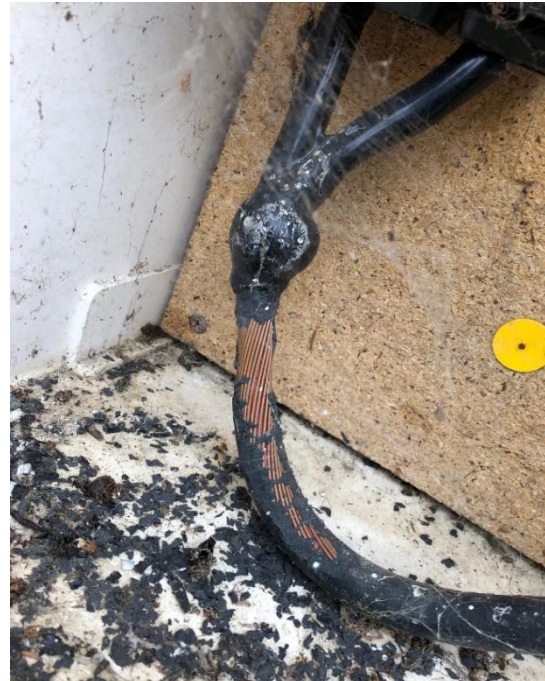
- Squashed / deformed service cables (e.g. the cable is squashed flat);
- Cables with severely damaged outer sheathing (e.g. where the conductor itself is visible). As the extent of the service cable damage is often unknown, severely damaged service cables should be reported as A04 regardless of the supply earthing arrangement.

Severely damaged service cable

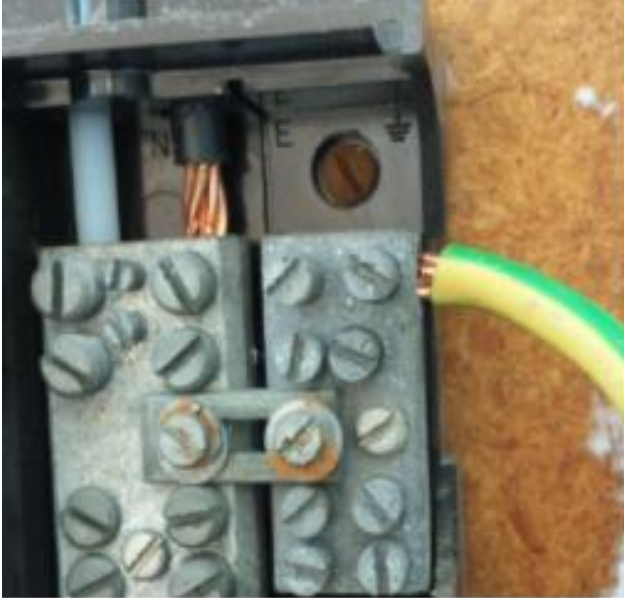
PME cut-out damaged (but not requiring immediate action) with neutral-earth terminal exposed by missing cover – report as Code C20

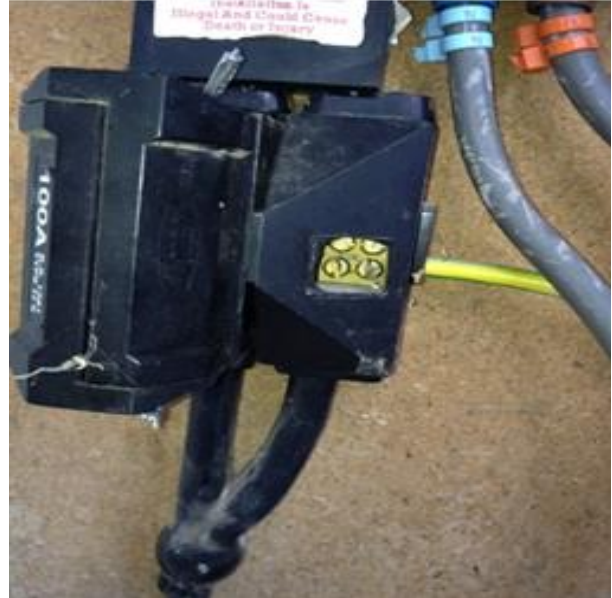
Knock out missing and the neutral-earth is exposed – do not report

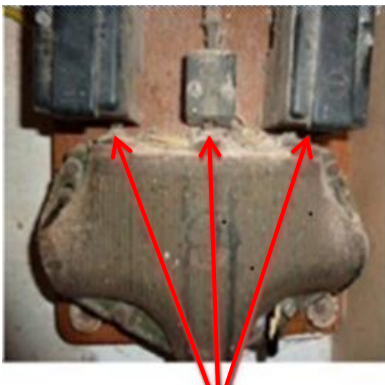
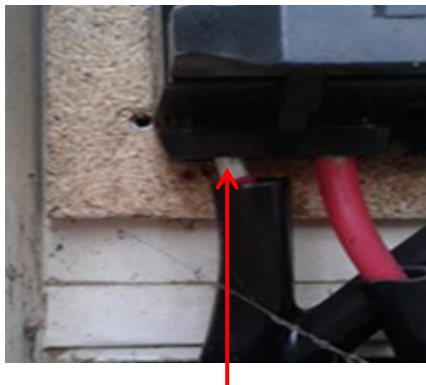
These are examples of cut-outs showing visible bare conductors from the cable termination to the fuse unit.

Visible bare conductors

- Do not continue to operate the DB equipment – unless mitigating actions have been taken to allow work to continue;
- If you are remaining on site for the DB to attend, keep the immediate area clear of obstructions and keep everyone at a safe distance;
- Contact the DB immediately by telephone – report as Code A07;
- Tell the DB what actions you have taken, if any;
- Remain on site until the DB staff arrive unless you have been able to take any mitigating actions to prevent danger in accordance with your company's risk assessment policy (see note below);

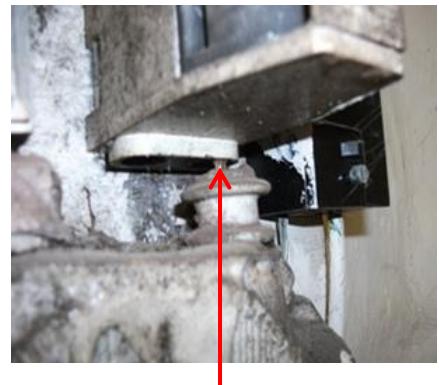
Exposed live conductor where the insulated trousers have slipped exposing the live conductor

Visible bare conductors

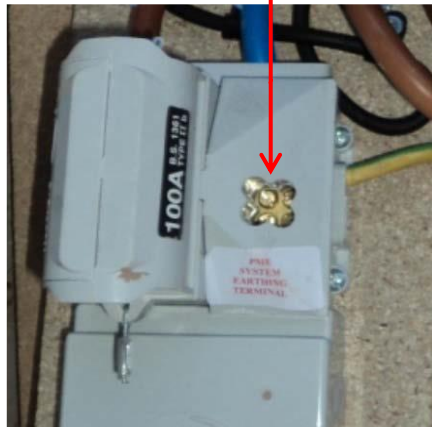
Earth terminal cover missing and the neutral-earth is exposed – do not report

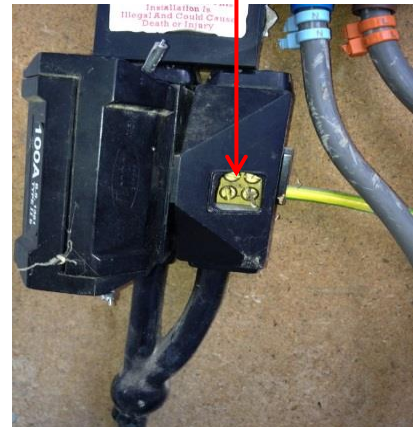
Knock out missing and the neutral-earth is exposed – do not report

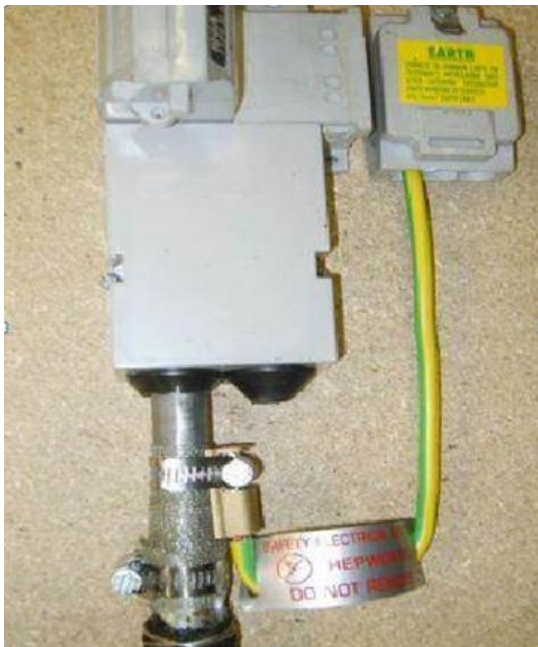
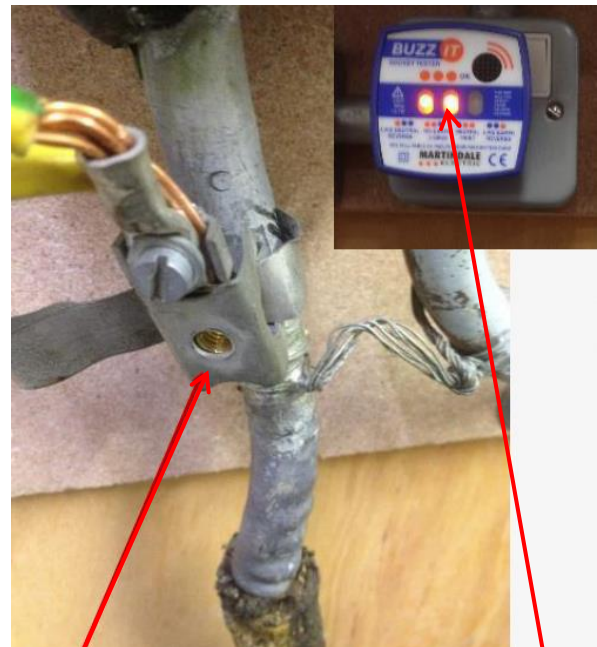
Screw missing from the earth clamp.

Socket tester indicates an earthing issue but further tests are required to confirm that the whole installation is not adequately earthed. If confirmed. Report as Code A10.

The photos below illustrate an earth connection using an earth clamp around the sheath of the service cable. If the clamp/connection is loose, do not tighten it, as this could potentially lead to cable damage and catastrophic failure. Loose earth connections attached to other parts of the DB equipment e.g. on a terminal at the side of a cut-out, may be tightened.

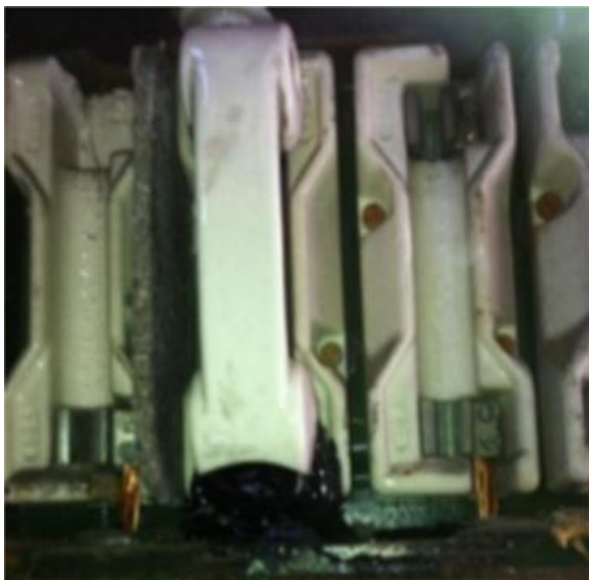
Fuse carrier welded into cut-out base

A fuse has become stuck due to bitumen compound rising up from the cable box beneath and “gluing” the fuse contacts

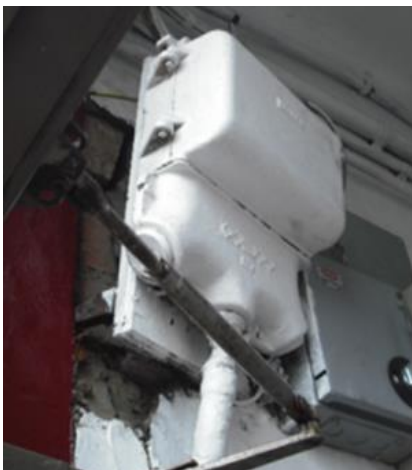
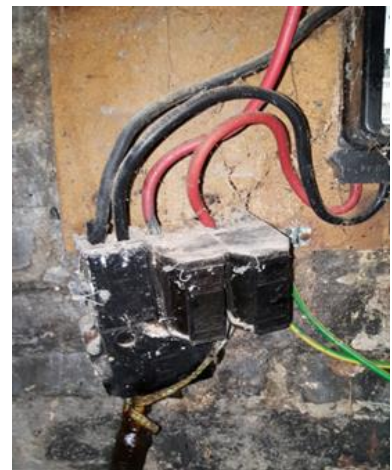
Examples of a cut-out that is clearly not securely fixed onto a wall

- Wherever possible, for safety and security reasons ensure the DB equipment is sealed before leaving site;
- Stop work and do not commence your meter installation activity;
- Report the issue to the DB via the data flow system – report as Code B02;
- Within the free text field on the data flow, please identify what equipment is located on the meter/backboard (including any customer equipment);
- Provide the DB with the customer’s name and contact number using the data flow system;
- To ensure the customer is fully aware of next steps, leave a Category B Customer Notification Card (or equivalent) to advise the customer to expect communication from the DB requesting an appointment to visit site to inspect the DB equipment.

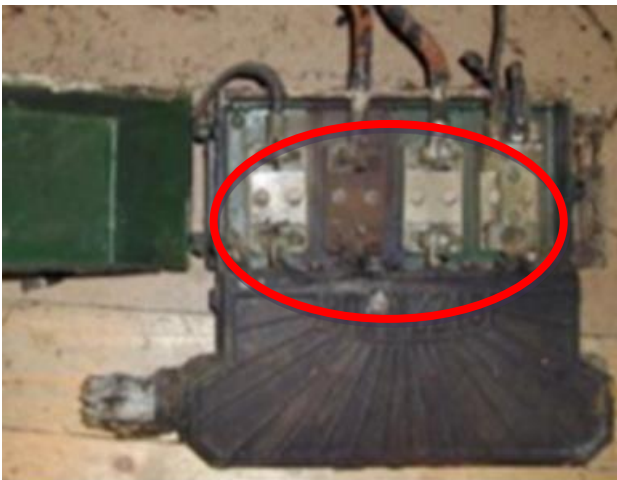
Missing phase barriers. Note the proximity of the incoming “stalks” to the metal cover

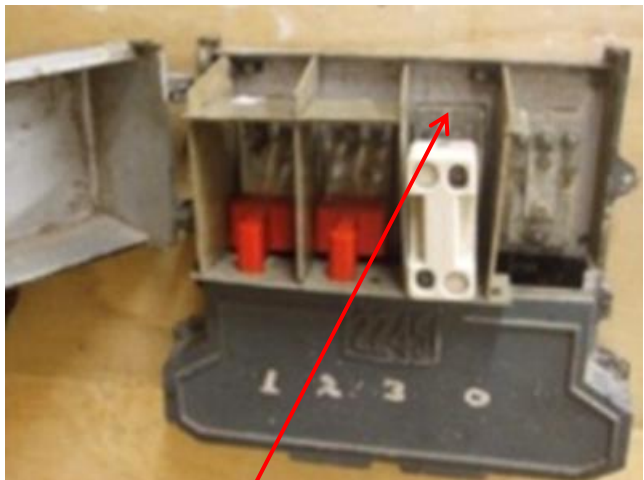
Missing phase barrier. Shrouds (in red) have been used by the Meter Operative to cover the live terminals

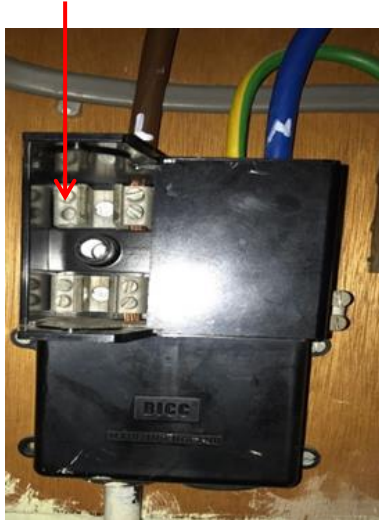
Missing screw. Meter Operative
able to continue with work - do
not report

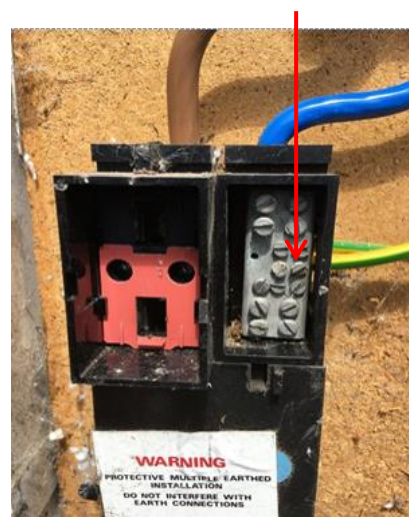
Screw sheared off. Meter
Operative able to continue with
work - do not report

- Wherever possible, for safety and security reasons ensure the DB equipment is sealed before leaving site;
- Stop work and do not commence your meter installation activity;
- Report the issue to the DB via the data flow system – report as Code B04;
- Provide the DB with the customer's name and contact number using the data flow system;
- To ensure the customer is fully aware of next steps, leave a Category B Customer Notification Card (or equivalent) to advise the customer to expect communication from the DB requesting an appointment to visit site to inspect the DB equipment.

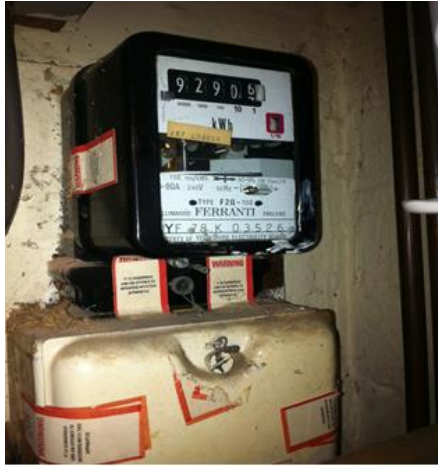
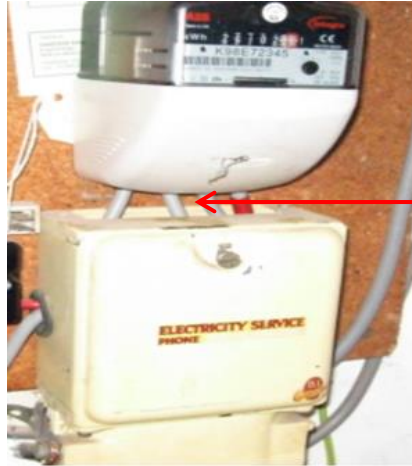
Raised position of meter could create a potential category A issue by leaving exposed live conductor(s) through the cut-out cable entry slot that were previously covered by the meter placed directly on top of the cut-out

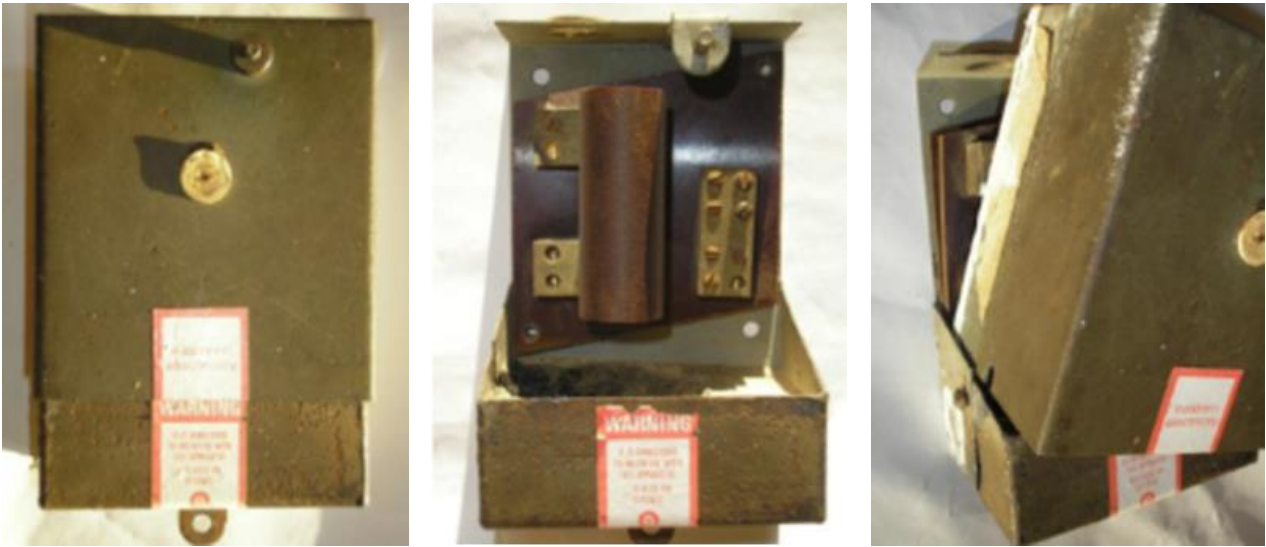
An uncommon type of pressed steel metal-encased cut-out, probably from the 1940s.

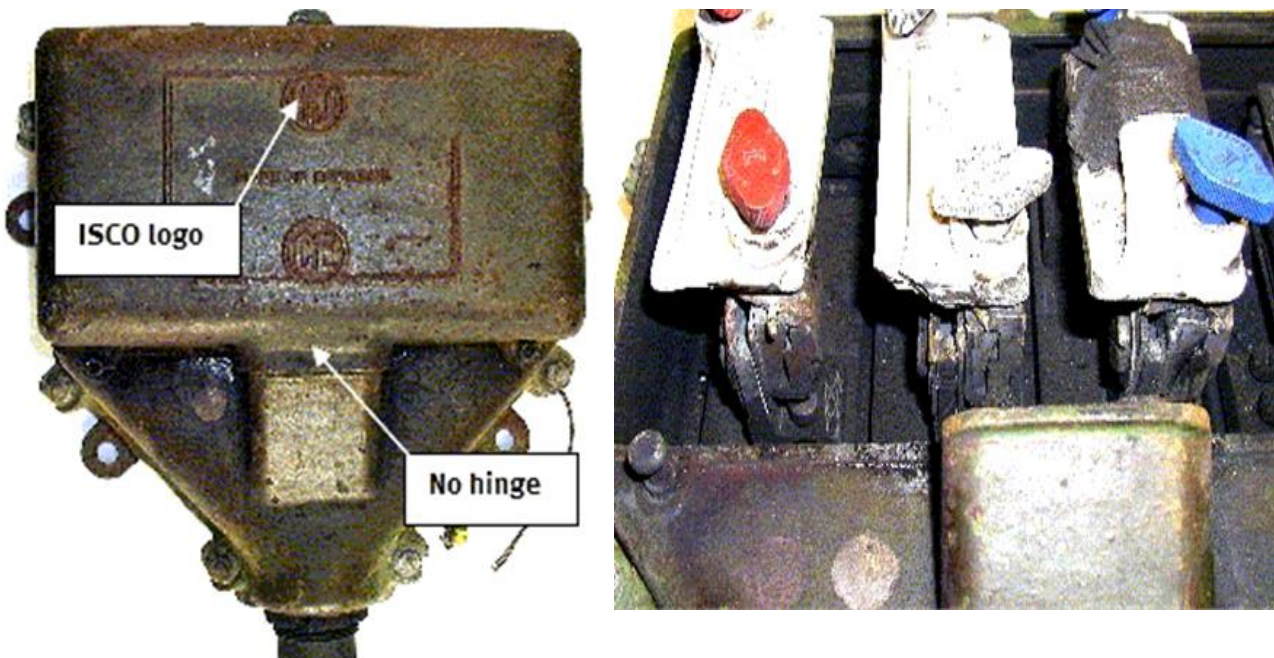
A typical example of a metal-encased cut-out which has known design deficiencies is the ISCO Type cut-out and extreme caution must be exercised when removing or replacing lids on this type of equipment. This particular example also had the phase barriers removed. All cut-outs must be assessed individually prior to attempting any live work on them ensuring that the phase barriers are in place.

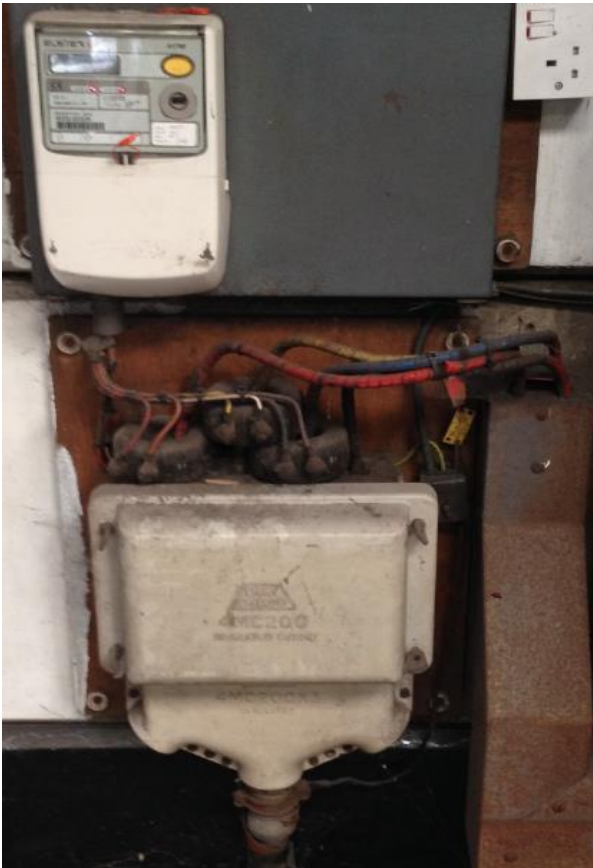
CT installation with missing test terminal block

- Wherever possible, for safety and security reasons ensure the DB equipment is sealed before leaving site;
- Stop work and do not commence your meter installation activity;
- Report the issue to the DB via the data flow system – report as Code B12. As this Code can be used for a variety of issues please provide a full description in the free text field;
- Provide the DB with the customer's name and contact number using the data flow system;
- To ensure the customer is fully aware of next steps, leave a Category B Customer Notification Card (or equivalent) to advise the customer to expect communication from the DB requesting an appointment to visit site to inspect the DB equipment.

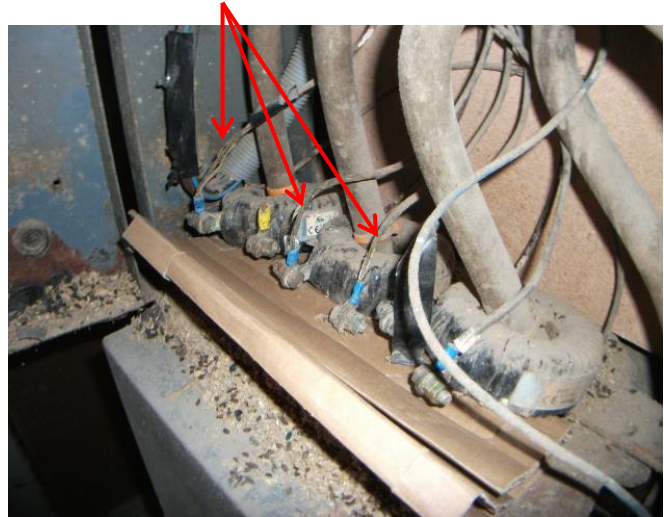
CT wiring insulation damaged by rodent infestation exposing inner conductor

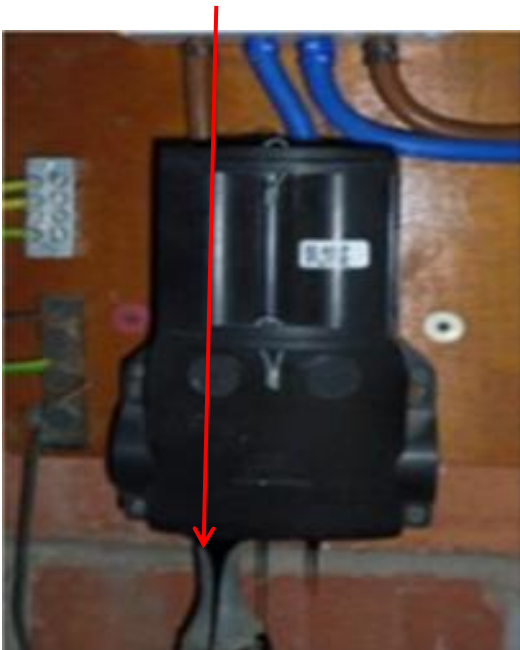
- There is no evidence of the DB equipment currently operating hot;
- The DB equipment appears in all other respects to be in good condition; and
- Compound has obviously leaked from the cut-out previously but is not currently leaking.

If the compound is currently leaking, report as Code A01.

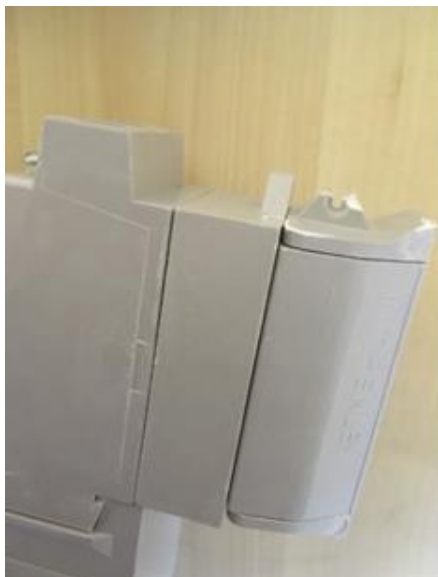
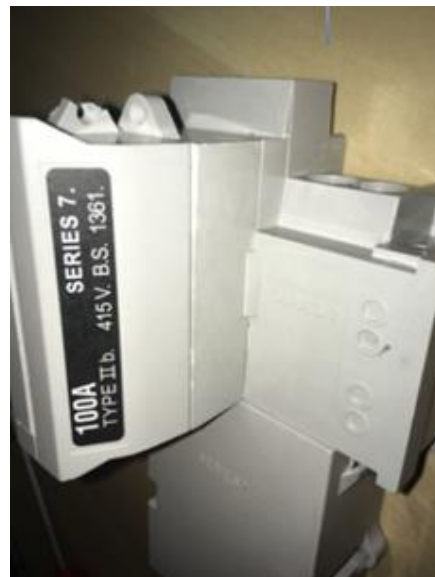
Examples: Photos showing where the tags are broken and it is not possible to seal the cut-out properly.

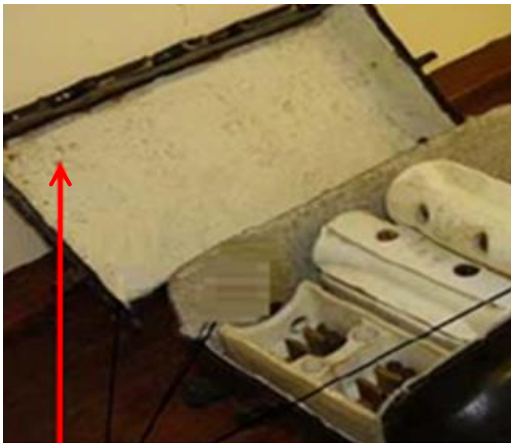
Coating and labels

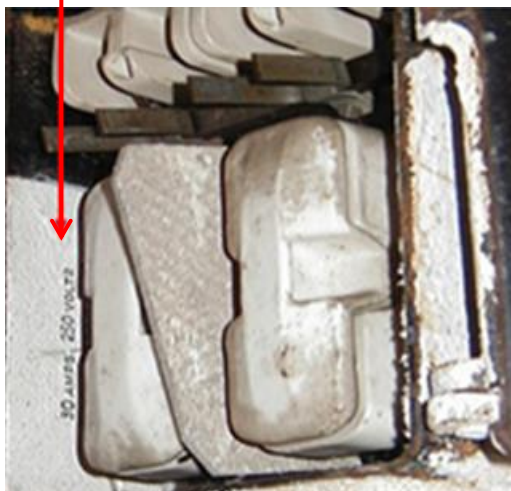
Asbestos wool

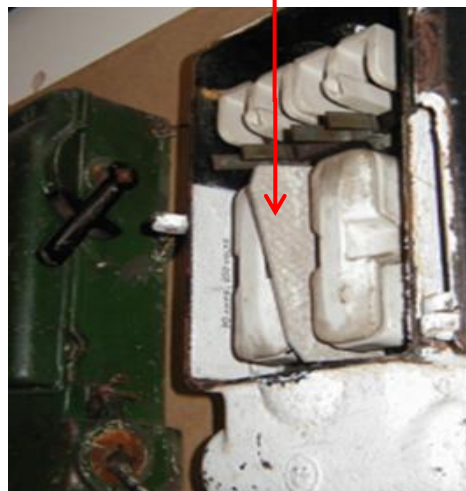
Asbestos phase barrier

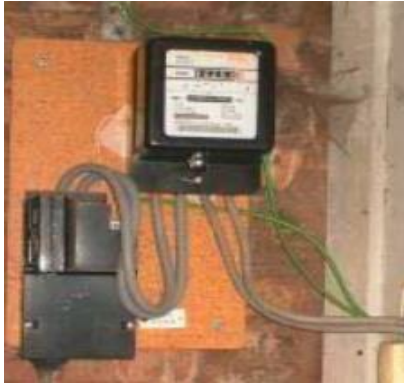
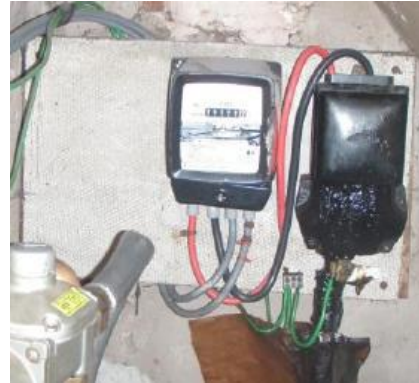
Following an on-site assessment you identify that the board to which the DB equipment is fixed is manufactured from Asbestos Containing Materials (ACM).
